Docket No. 217 – Development and Management Plan Inspection

Northeast Utilities Service Company Certificate of Environmental Compatibility and Public Need for the construction of a 345-kV electric transmission line and reconstruction of an existing 115-kV electric transmission line between Connecticut Light and Power Company's Plumtree Substation in Bethel, through the towns of Redding, Weston, and Wilton, and to the Norwalk Substation in Norwalk, Connecticut.

Date: November 2, 2005

Location: 345kV Underground Route

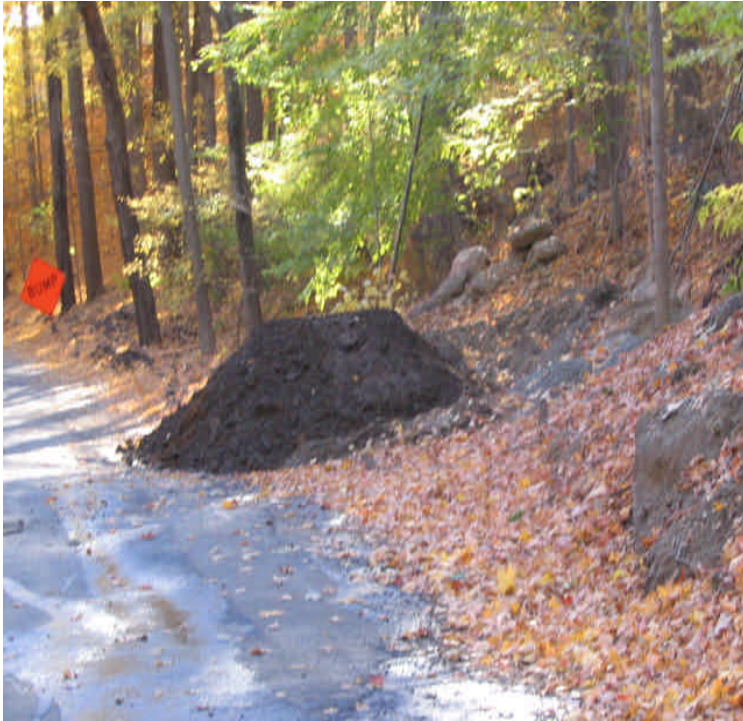
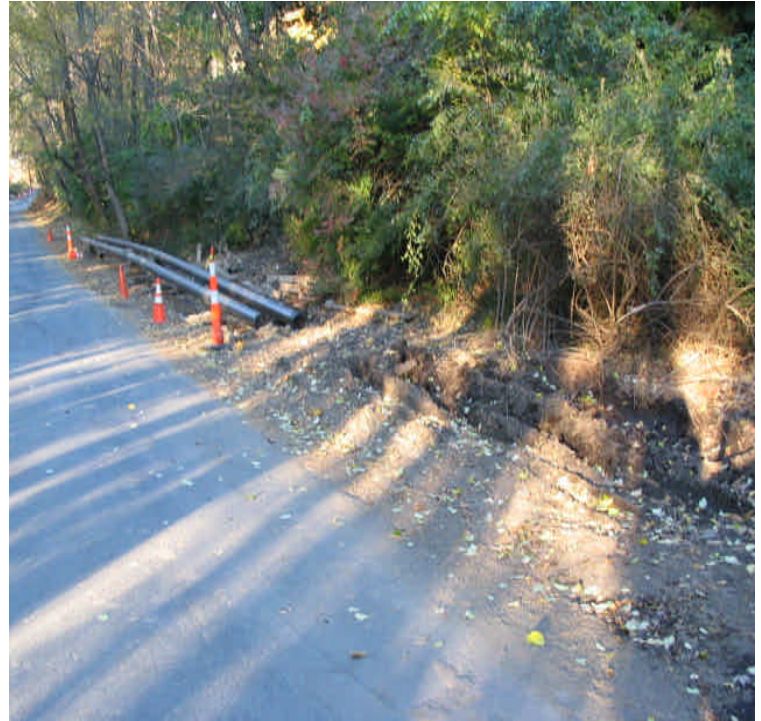
345kV (Umpawaug Rd Daywork): The photo on the left shows a stockpile left near the Diamond Hill Rd. end where some work has begun. Silt fence should be placed downgradient here. The photo on the right shows some ruts on the edge of the road near the Rt. 107 intersection. 11/2/05

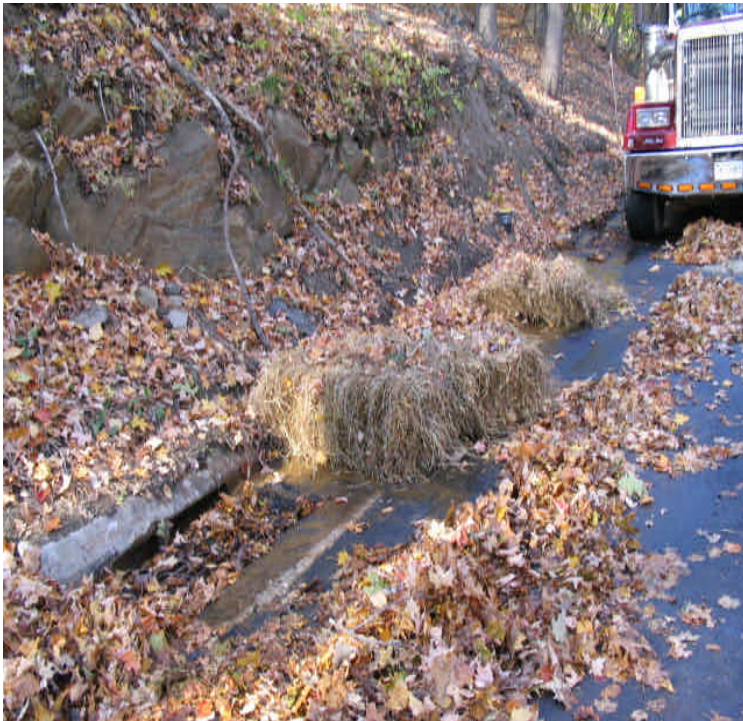
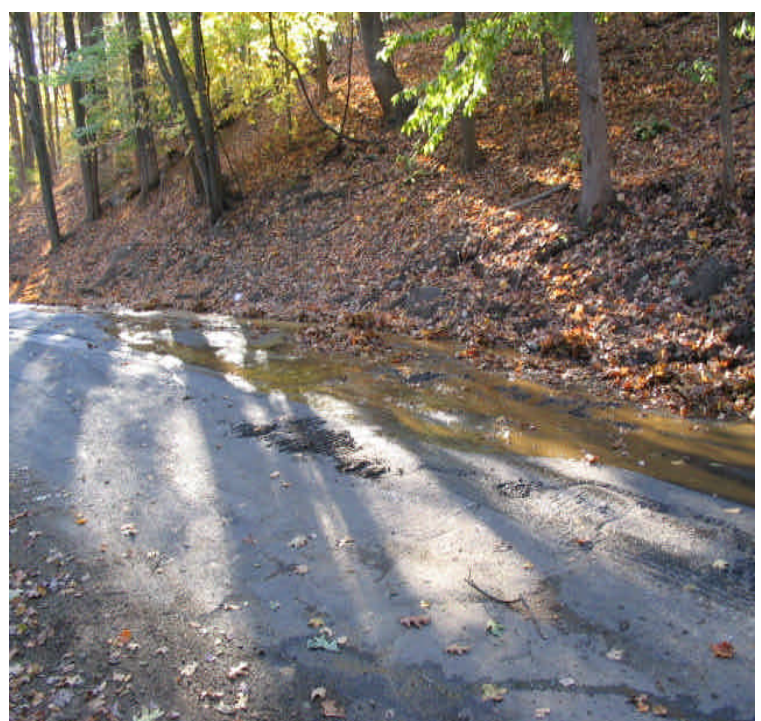
Photo on the left shows where haybales were placed after turbid water was observed running from an open trench. Photo on the right shows the water not being very effectively filtered by the haybales and leading to a catch basin. 11/2/05

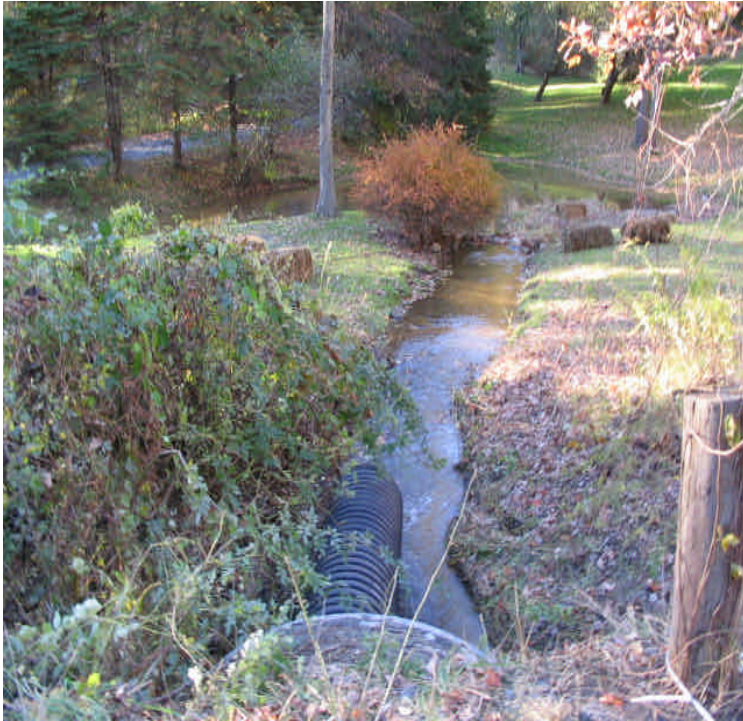
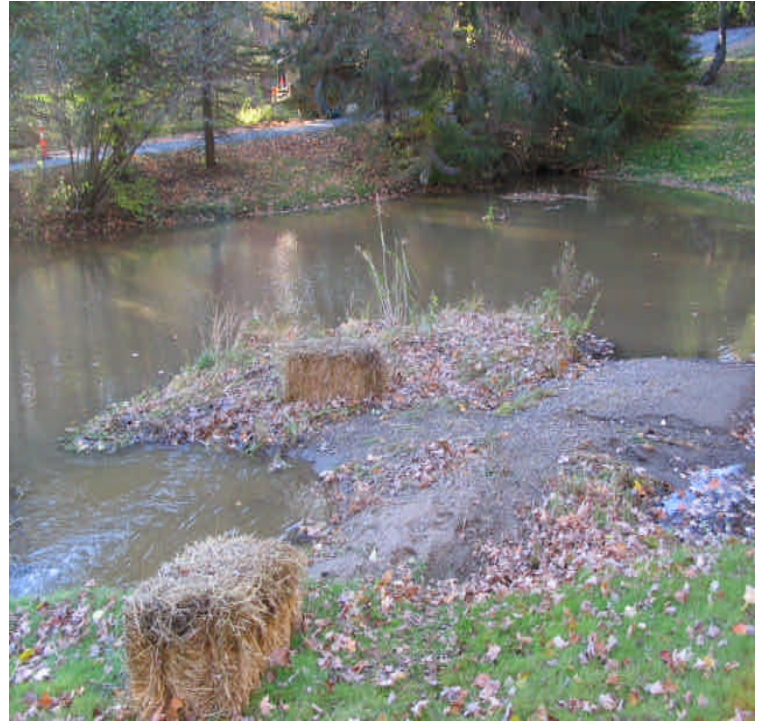
Photos show the pond near Parsons Lane as the receiving water for the turbid outfall of the catch basin. The water coming in from the corrugated pipe was completely clear but the turbid flow on the right hand side was apparently from the CB outlet. Haybales were placed following the discovery but did not have much effect. 11/2/05

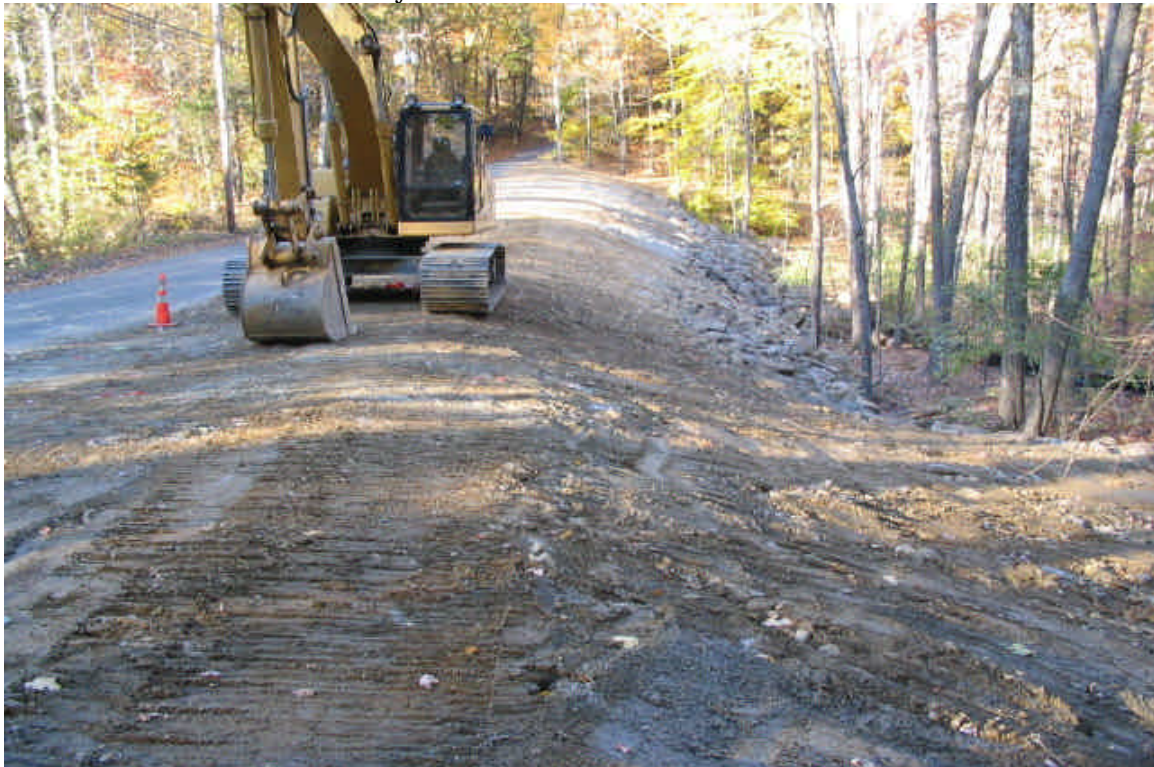
View of some widening work along Umpawaug Rd but it was uncertain whether the work is related to 345kV. Work was over a stream but erosion controls were well in place. 11/2/05

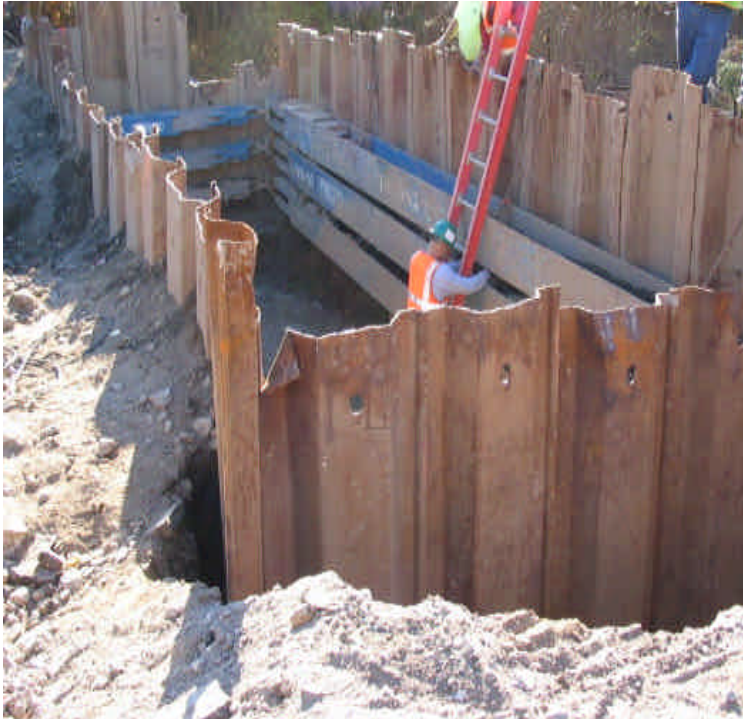
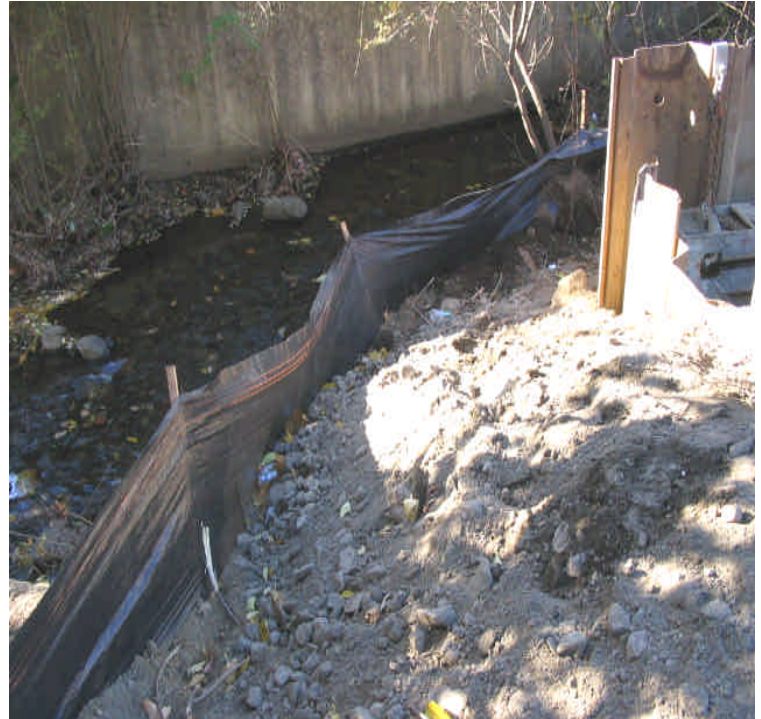
345kV (Route 107- Georgetown Jack and Bore): Photo on the left shows the overall view of the jacking pit constructed at the Georgetown Deli lot. Photo on the left shows the erosion controls in place. A small gap under the fence will be placed with clean sand to toe in the fence. 11/2/05

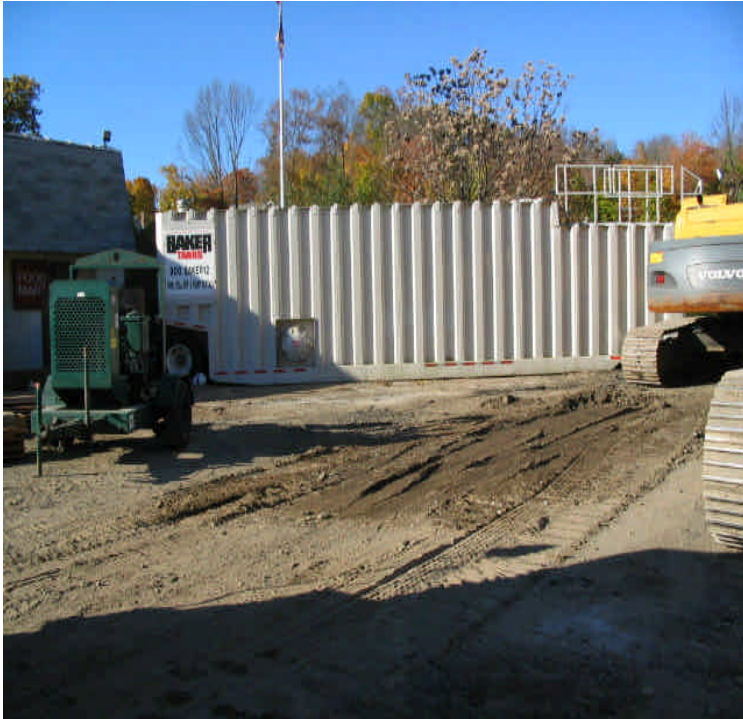
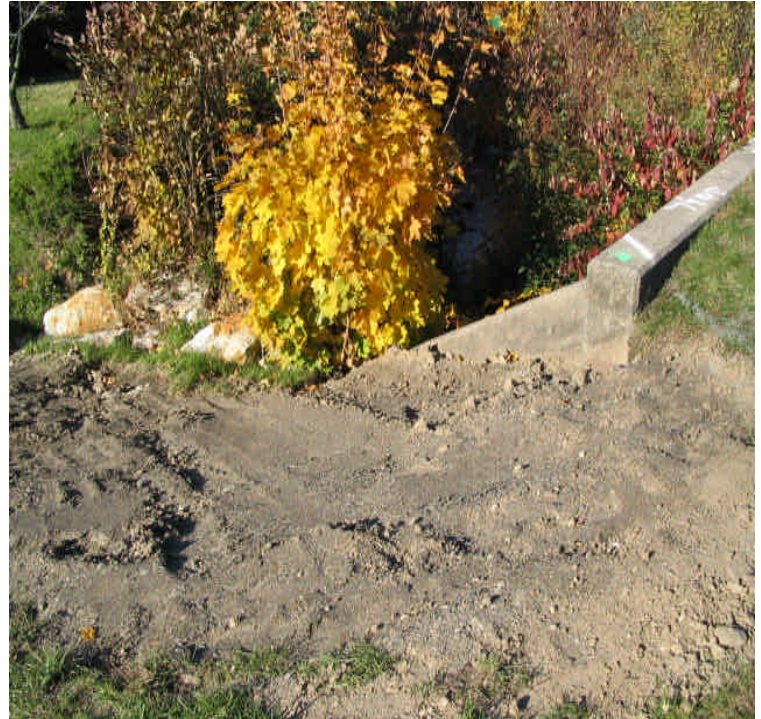
Photo on the left shows one of the several frac tanks that will be handling the dewatering discharge here. Photo on the right shows the area on the other side of the stream where the receiving pit will go. Some soil sampling here created an area of bare soil which should have erosion controls installed. 11/2/05

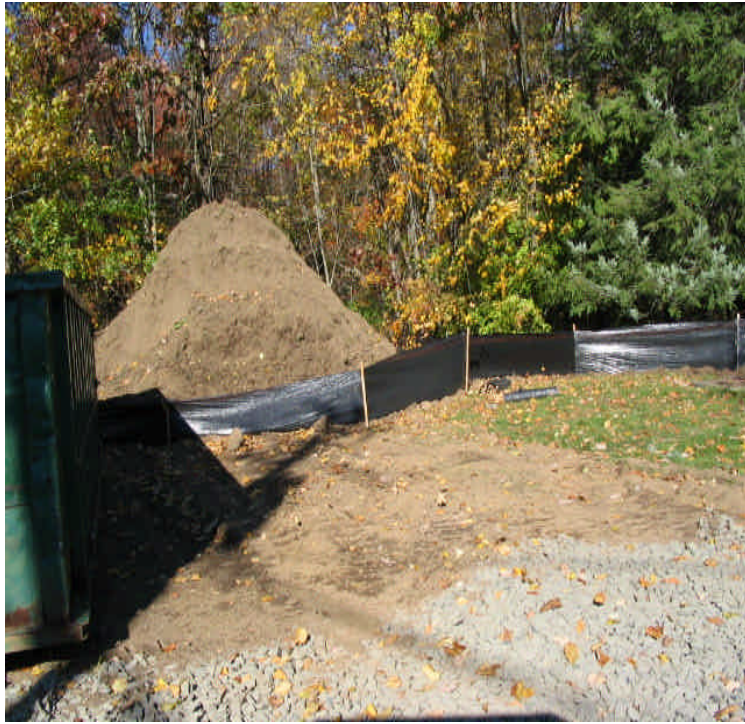
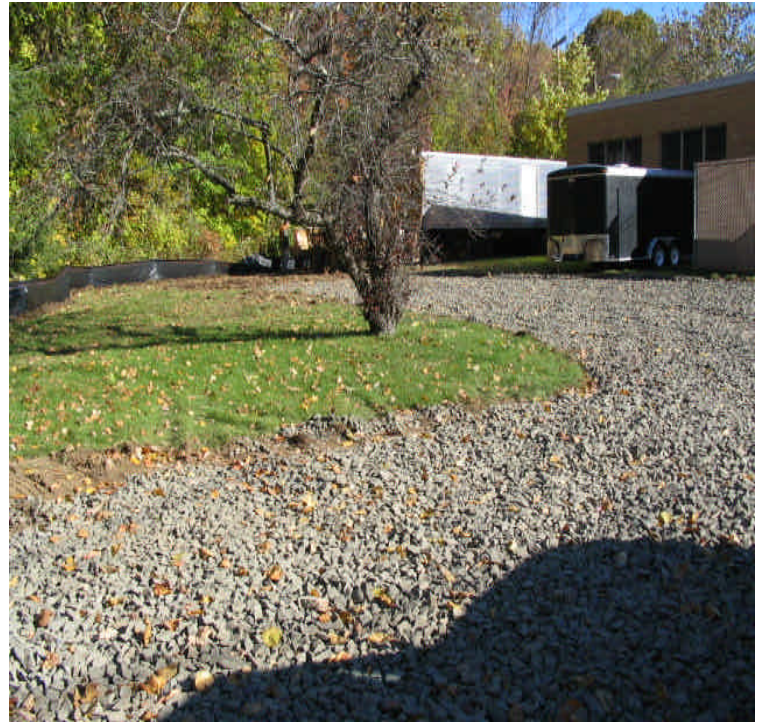
345kV (Rt. 7, CL&P yard): Some prep work was occurring at the CL&P yard with erosion controls installed, topsoil removed and stockpiled and stone placed. Erosion control installation was continuing at the time of inspection and still needed to enclose the back of the stockpile. 11/2/05

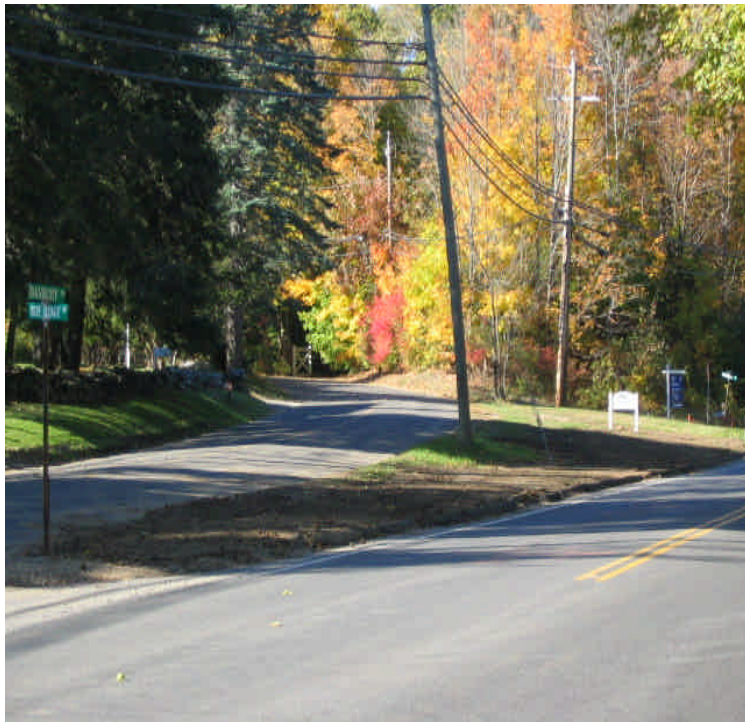
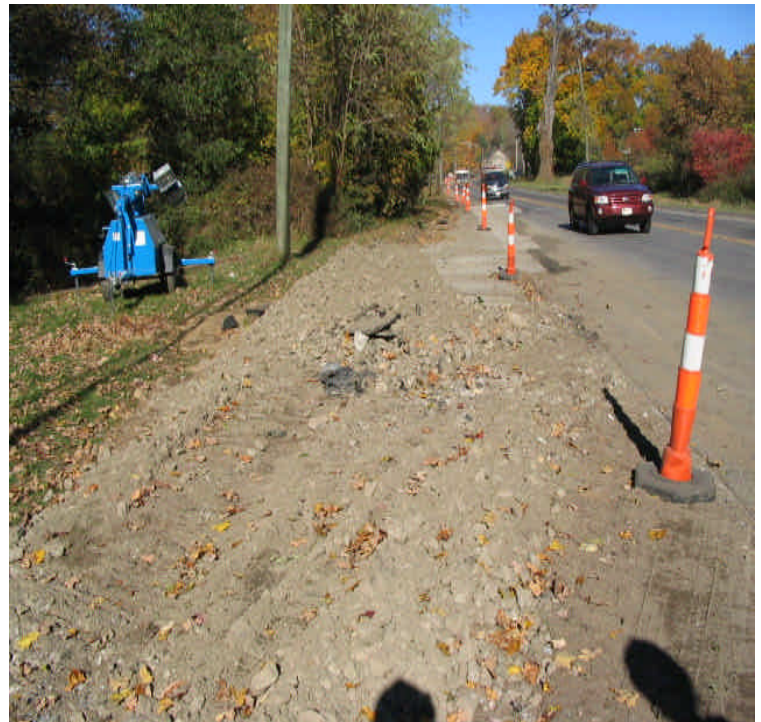
345kV (Rt. 7): Photo on the left shows some areas along the roadway where restoration had occurred. Photo on the right shows where work ended for the night just off the roadway near Allen's Meadow. 11/2/05

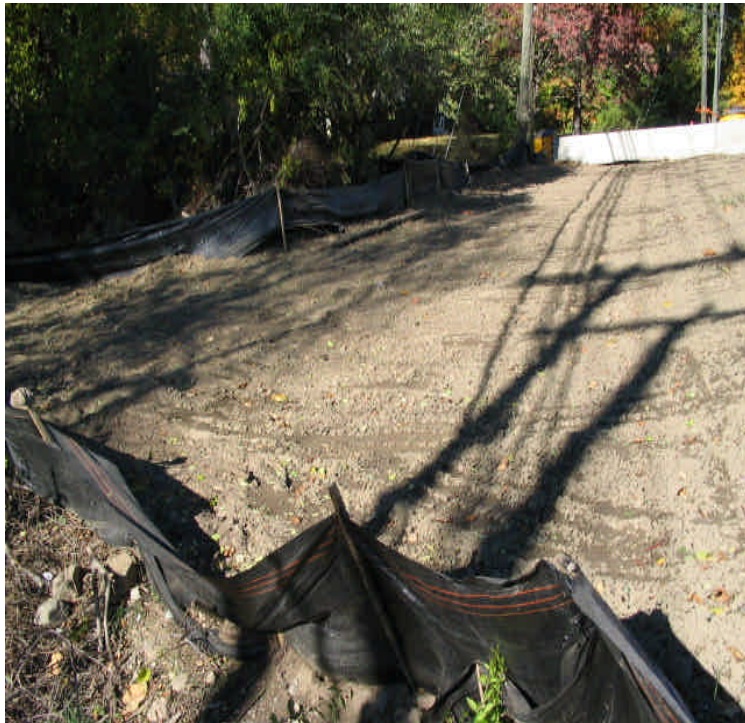
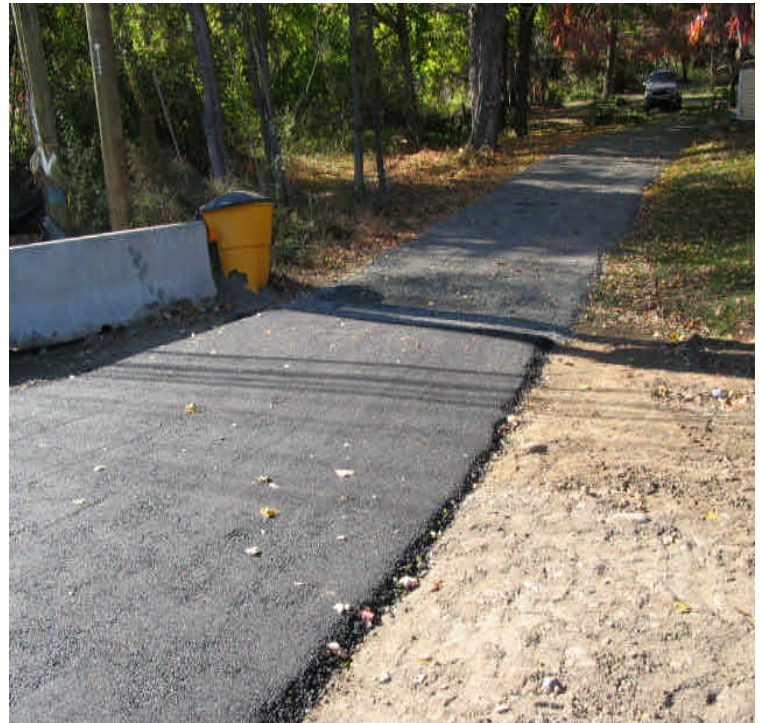
345kV (Wilton HS J&B): Photo on the left shows the north side of the stream where the receiving pit was filled and regraded. Photo on the right shows where a neighbor's driveway was repaved following the trenching here. 11/2/05

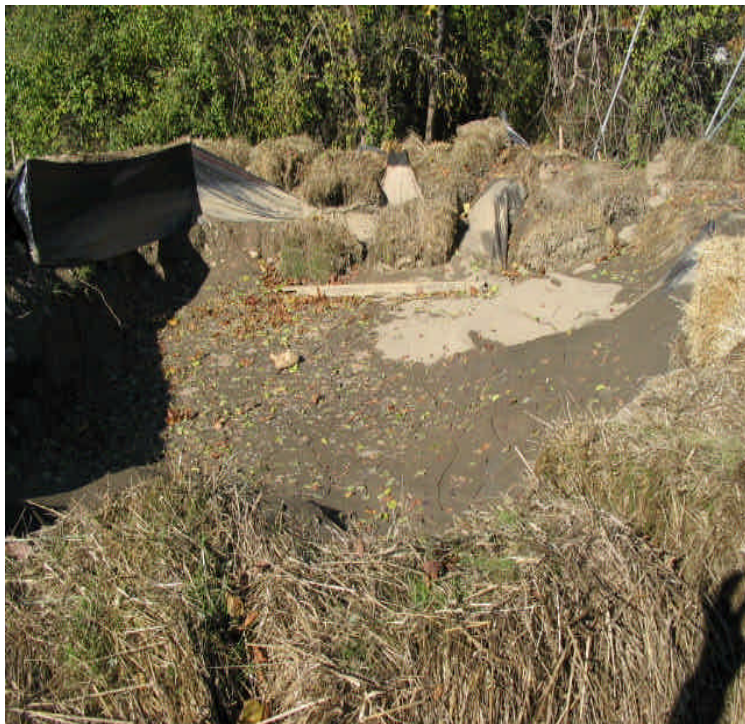
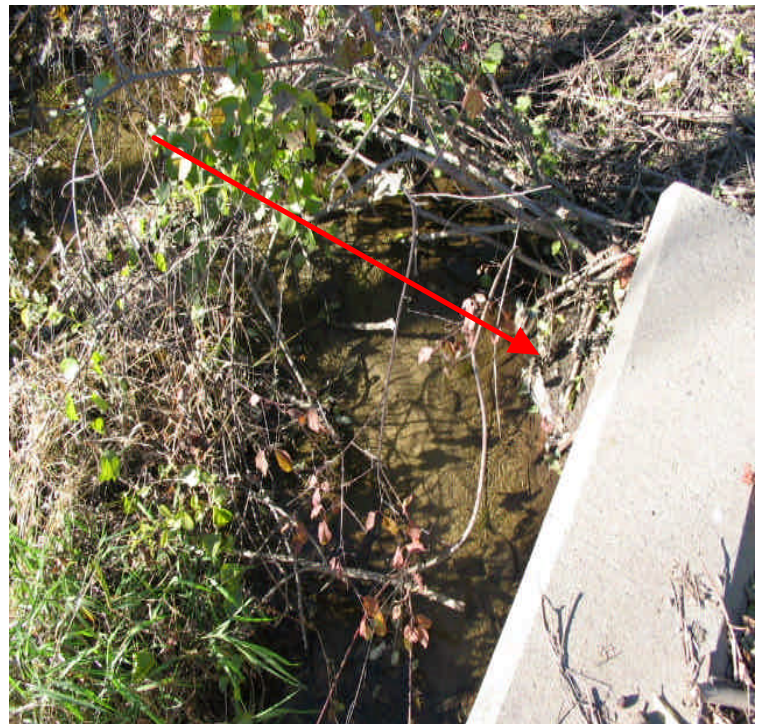
Photo on the left shows the settling basin no longer in use for the 345kV project and filled with sediment. The town will be using this for a sewer project but should clean out/revamp the entire basin before use. Photo on the right shows where some accumulated sediment should be removed from the stream. 11/2/05

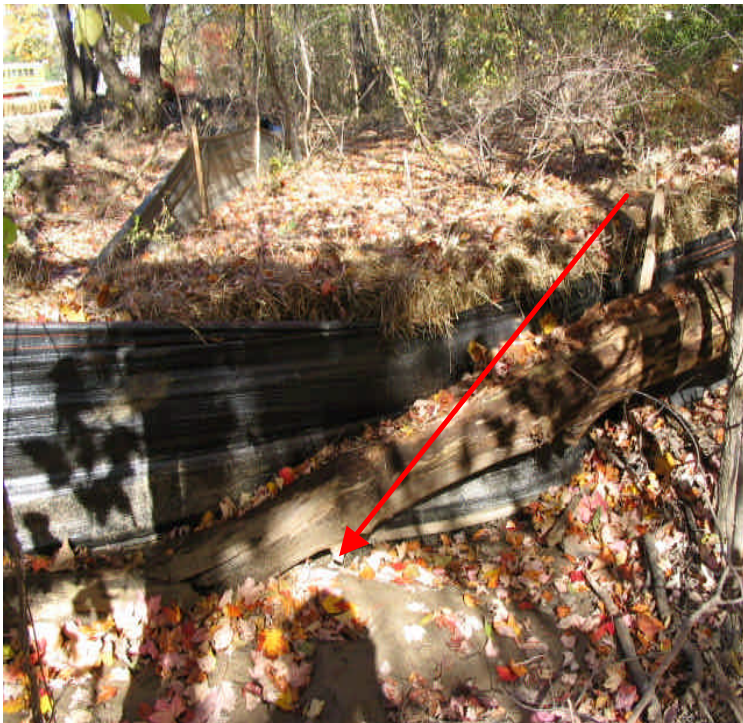
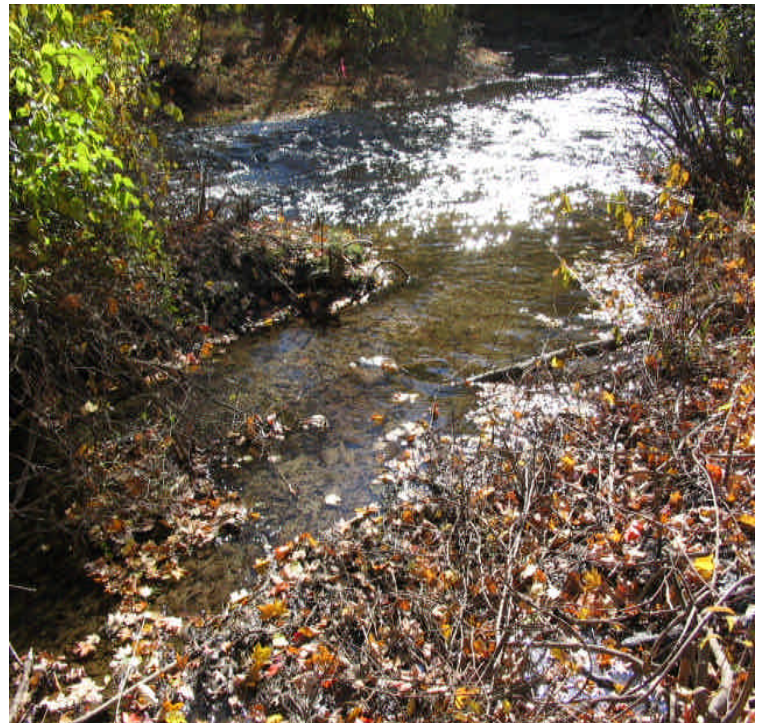
345kV (HDD): Photo on the left shows where the outer erosion controls could use some maintenance. A small gap was noted under the silt fence. Photo on the right shows where the accumulated sediment was removed carefully from the Norwalk River channel. 11/2/05

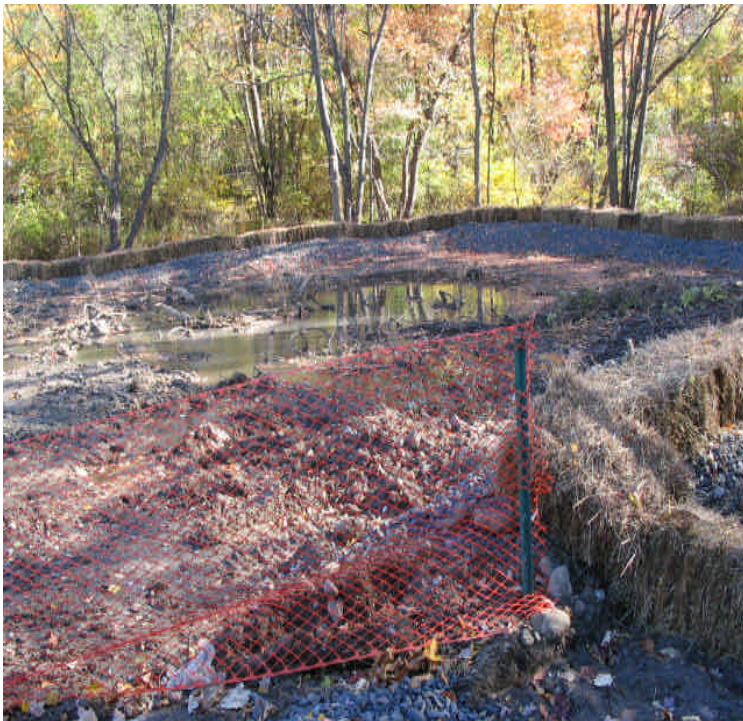
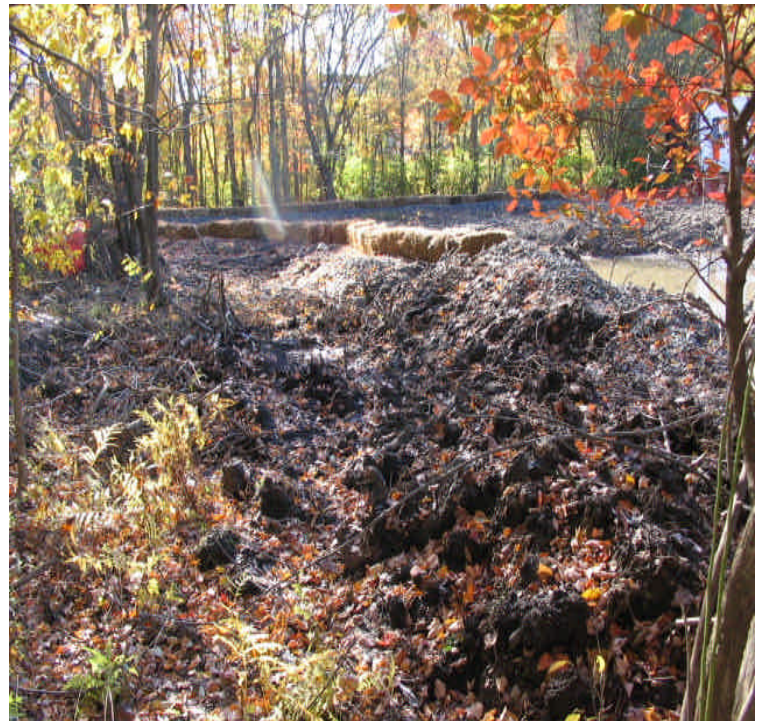
Photo on the left shows the detention area with some standing water. The perimeter berm is in good shape and the basin works well. Photo on the right shows the area to the east of the site where additional controls should be installed. 11/2/05
